## **SUBJECT: ISSUE WITH HITCH PIN ASSEMBLY (2017661 REV 0)**

This Hitch Pin Assembly (JBW# 2017661 Rev 0) was used in the following larger assemblies, on units built before 02/25/2022:

<b>JBW# 2018555</b>	INSTALL KIT-100TT FRONT PREM POP UP 1045
<b>JBW# 2018525</b>	INSTALL KIT-100TT REAR PREM POP UP 1045 CARBON
<b>JBW# 2018556</b>	INSTALL KIT-100ST FRONT PREM POP UP 1045

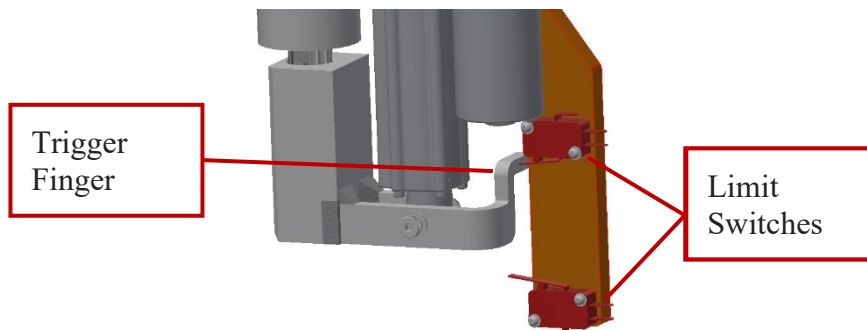
How to know if there is a problem:

- If you can lightly pull the trigger finger past the limit switch
