JERVIS B. WEBB COMPANY

Service Bulletin: SHS- 2011-005

SUBJECT: LOADING HP / COLUBRIS RADIO FIRMWARE

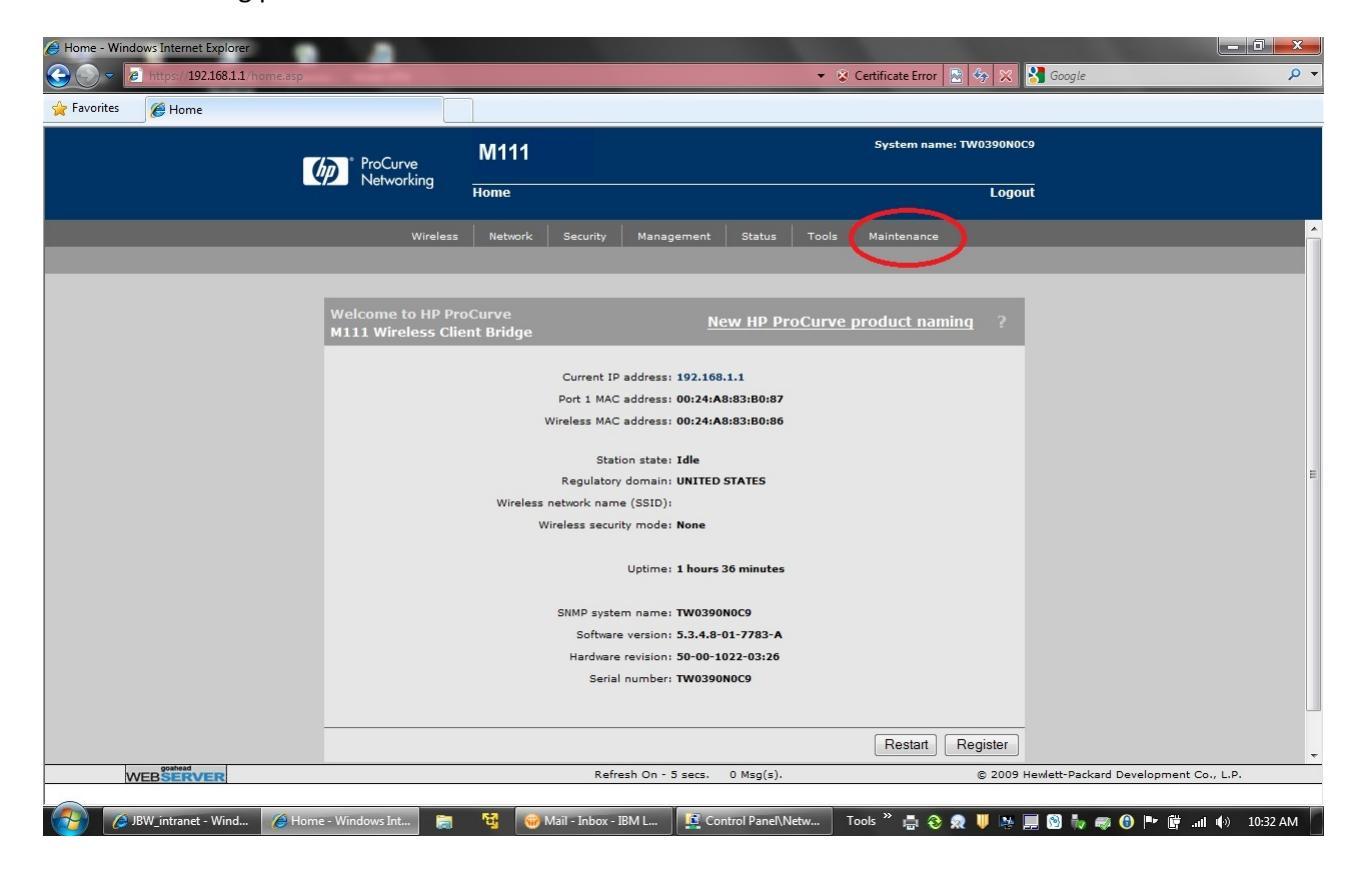
4. Reconnect to your radio and login. Once you are at the home page, click on the maintenance tab as seen in the following picture
